RENEWWRAP®

CASE STUDY:

Greenville, SC Column and Cap Repair

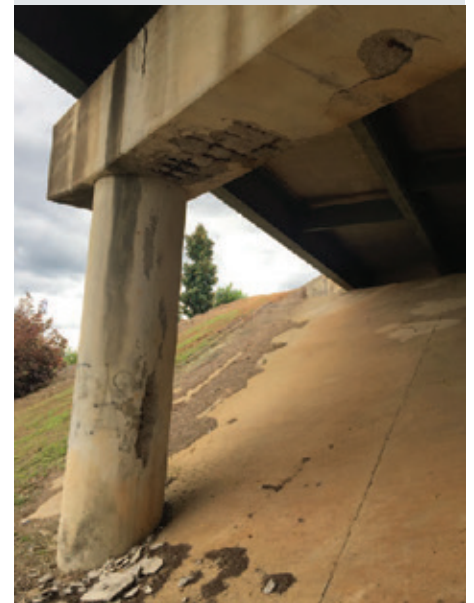
The SCDOT found corrosion-related deterioration of the pier caps and columns supporting the Butler Road bridge over I-385 in Greenville, SC, during a routine inspection. The corrosion was caught early enough and was limited to only one column and a couple of locations on the pier cap to be repaired by the SCDOT maintenance crews. To prevent further deterioration, the SCDOT determined it was necessary to repair the damage, restore any loss of strength and protect the pier from further deterioration. A repair that could be made quickly and with as little disruption to the traveling public was important.

Column and pier cap prior to repair.

Engineers visited the job site with the SCDOT to assess the scope of the problem and understand the objectives of the SCDOT. After the site visit, MIS recommended using GeoStrong® geopolymer repair mortar to make the vertical and overhead spall repairs on the pier cap, followed by the application of a single layer of RenewWrap FRP strengthening system to restore any loss strength and to protect the pier cap from further deterioration.

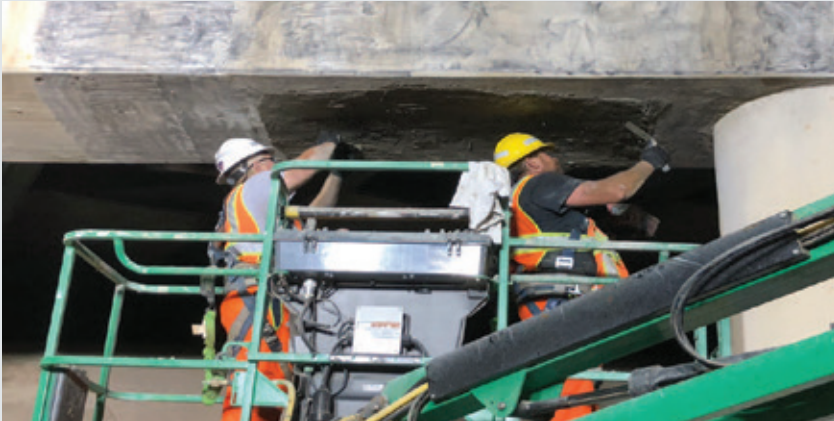
Application of GeoStrong repair mortar.

The work was completed by the SCDOT maintenance crews in the evenings to minimize lane closures on I-385. Standard concrete repair methods were used by the SCDOT to make the repairs. Once the loose concrete was removed and the corroded rebar was cleaned, the GeoStrong geopolymer repair mortar was placed by hand to fill the spalled sections. Unfortunately, heavy rains in South Carolina forced the crew to shut down before the patching could be completed. When they returned two weeks later, they could patch directly over the cured GeoStrong material with confidence knowing that cold joints are not a concern with MIS's innovative geopolymer material.

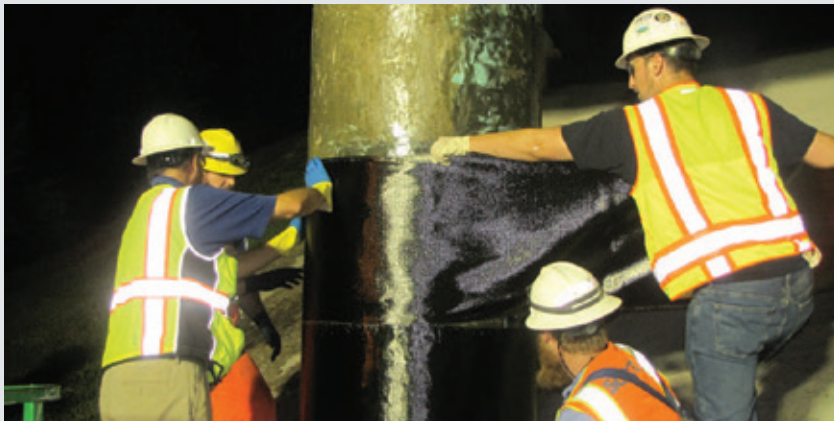
SCDOT maintenance crew wrapping pier cap with RenewWrap FRP system.

When the GeoStrong mortar was applied and cured, MIS engineers instructed the maintenance crew on how to apply RenewWrap FRP system to the pier cap and column. The carbon fibers were aligned in the same direction as the corroded reinforcing steel to provide additional strength and protection to the damaged areas. The following night, the SCDOT coated the RenewWrap with a Sherwin-Williams epoxy paint to match the rest of the pier. To the traveling public, the pier looks like a brand-new structure.

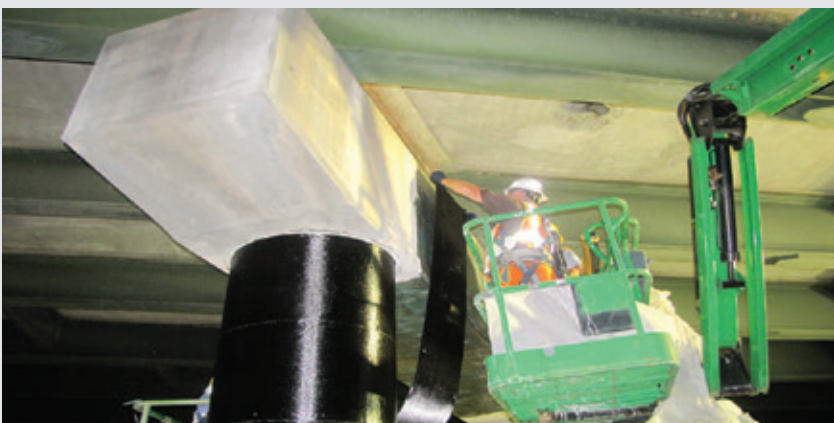
Application of RenewWrap FRP around column for confinement.

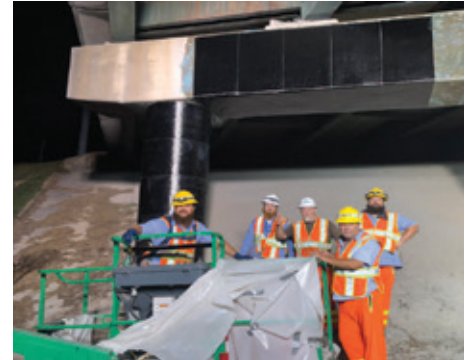
Completed repairs prior to coating.

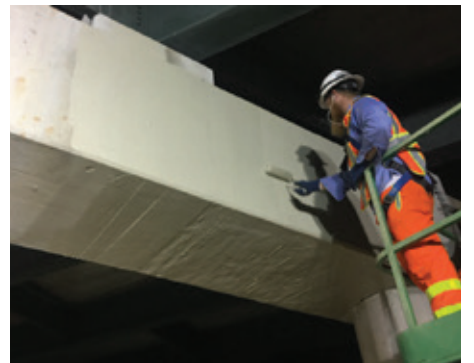
Painting RenewWrap FRP system with epoxy coating.

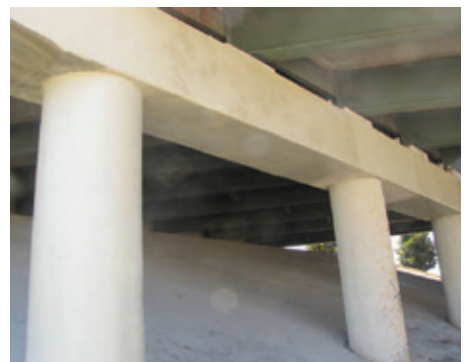
Completed column and pier cap.
