# W South Beach Hotel

Miami Beach, Florida, USA (2016)

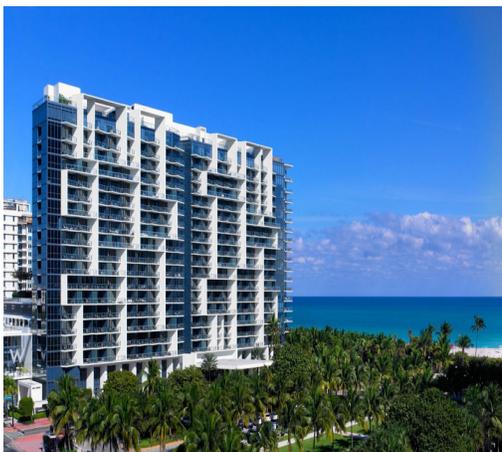
*W South Beach Hotel had leaks that could have caused a serious flood problem*

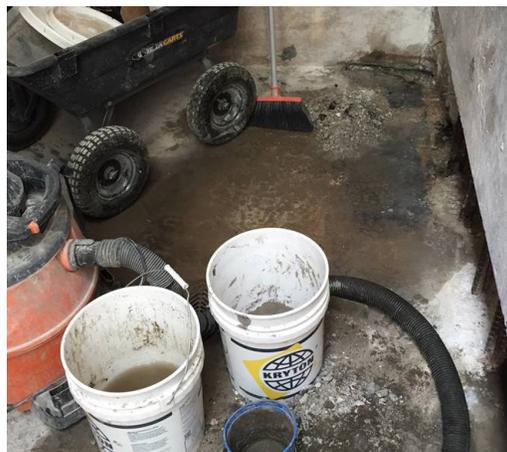
*Krystol Plug and Krystol Repair Grout stopped the leaks and repaired the cracks in various areas of the foundation slab and walls.*

The contractor on the repair job was EC Consulting Partnership. They realized Kryton's Krystol® technology was the best choice for this particular issue. Krystol Plug™ and Krystol Repair Grout™ were used to stop the leak, fill the crack, and seal the space. The two products repaired numerous areas of the foundation slab and walls of the hotel. Not only did the application of Krystol Plug and Krystol Grout stop the leak and repair the cracks in the concrete, but it was also easy to apply, cost effective, and will work for the life of the structure. This means that EC Consulting will not be called back for more costly repairs to the same area.
