FIELD REPORT—FastPatch DPR

Spall Repair CA-86

Scope of Work:	Spall Repair
Date of Installation:	2/19/2014
Location:	CA-86 South Bound PM 36.1, Brawley, CA
Product:	FastPatch DPR Kit
Installer:	Caltrans Road Maintenance Crew (District 11)
Reviewed by:	Rob Loomis, Jason Keylon

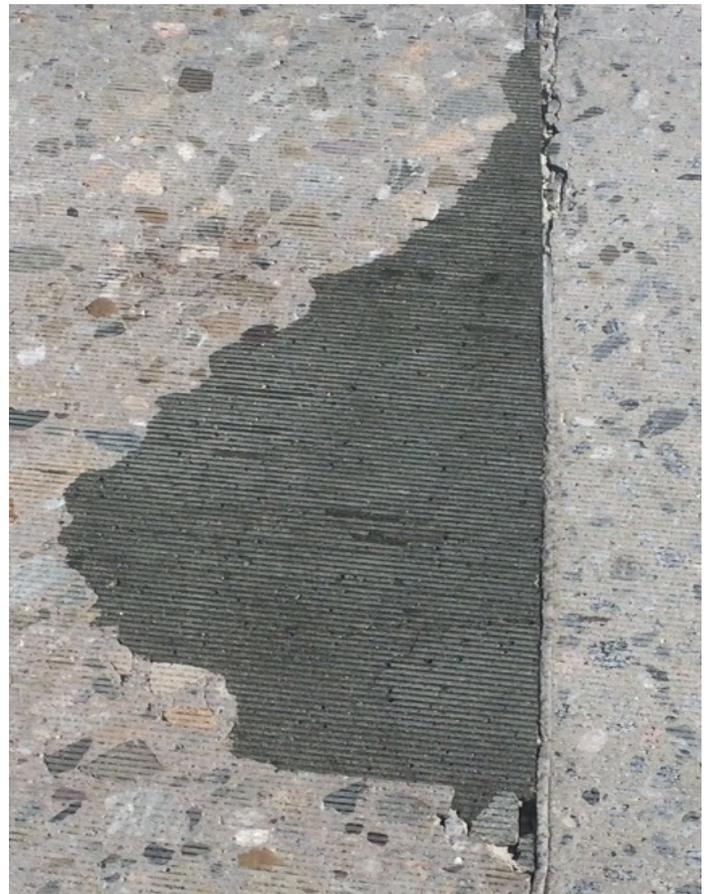
Figure 1: FastPatch DPR after grinding.

Spalls on Route 86 were in need of repair with a material that would extend the pavement life and improve safety. FastPatch DPR (Distressed Pavement Repair) was used because it has excellent adhesion and is easy to install with minimal preparation to the concrete. The spalled area was prepared by removing loose concrete and blowing the area clean. Follow up reviews were done one month later and another 14 months after installation. During that time a contract was awarded which included grinding and shows how FastPatch DPR repair is still bonded very well to the concrete.

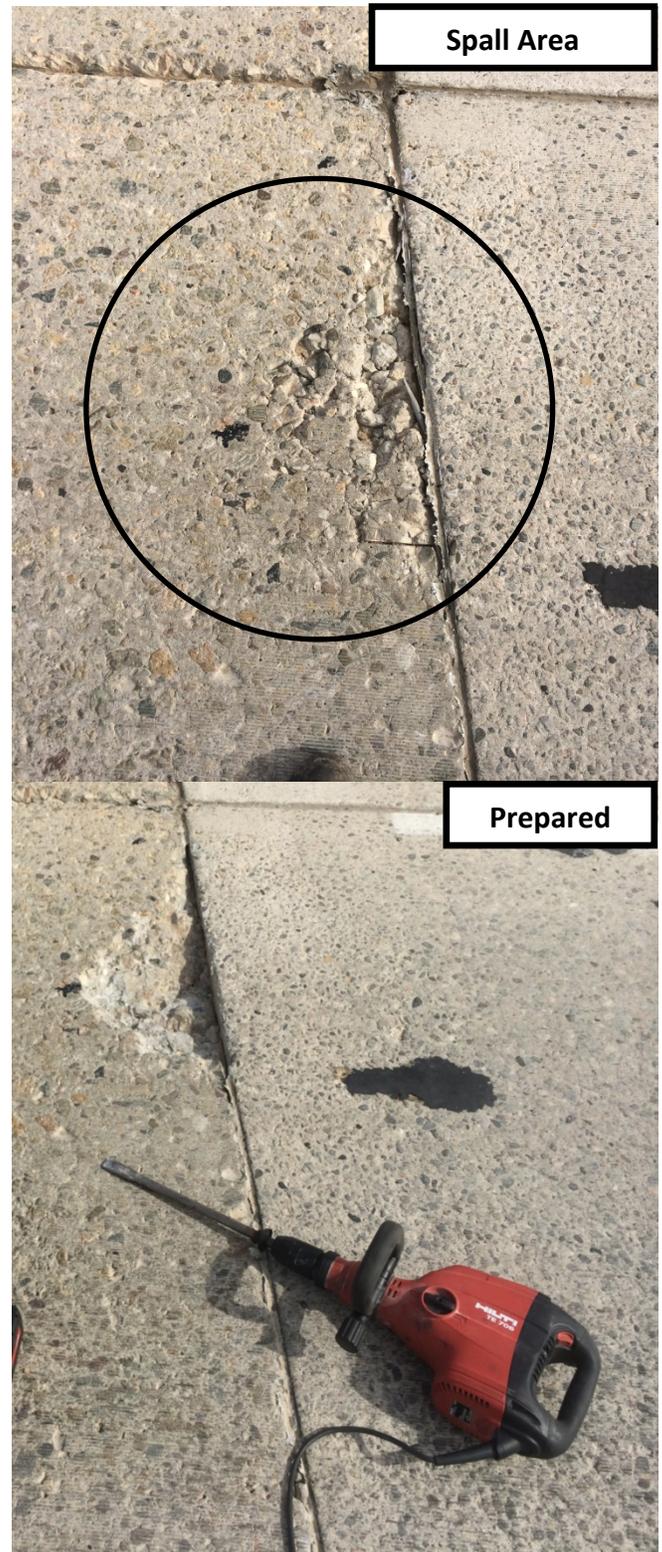
1. Used Hilti TE-1000 electric chipping hammer and digging bar to remove loose concrete. Cleaned surfaces with compressed air 120CFM to remove dust and loose material.
2. Opened PART A pouch and poured into center of aggregate. Mixed using an 'Eggbeater' style in the center of the mixing container for 1 to 2 minutes while scraping bottom and sides of container.
3. Open PART B pouch and poured in the mixing container and mixed about 1 to 2 minutes while scraping bottom and sides of container with mixer.
4. Immediately poured and spread over area leveled to the surrounding elevation.
5. Applied topping sand to refusal after 5 minutes and opened to traffic after 45 minutes.

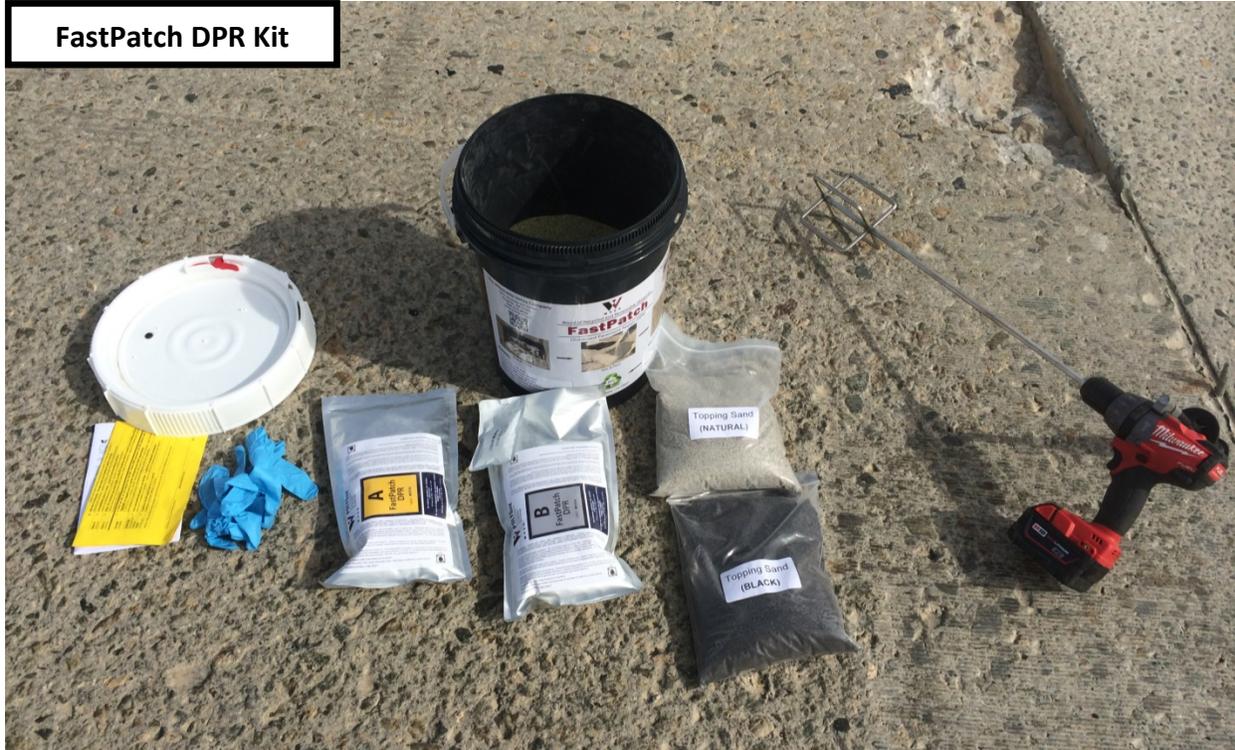
FastPatch DPR Kit

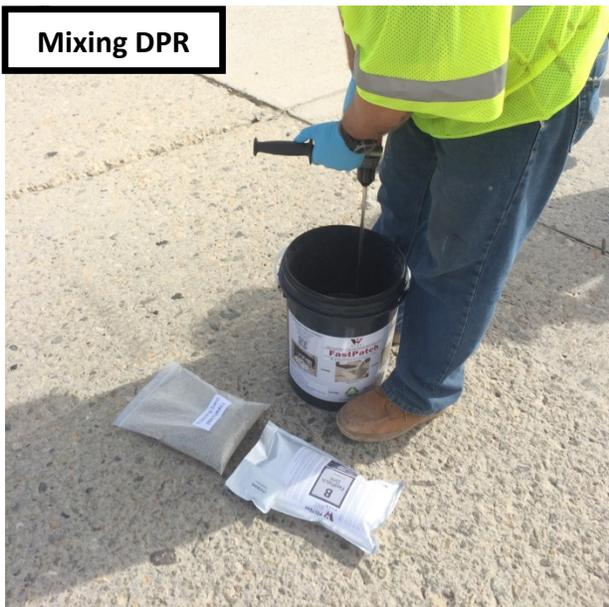
Mixing DPR

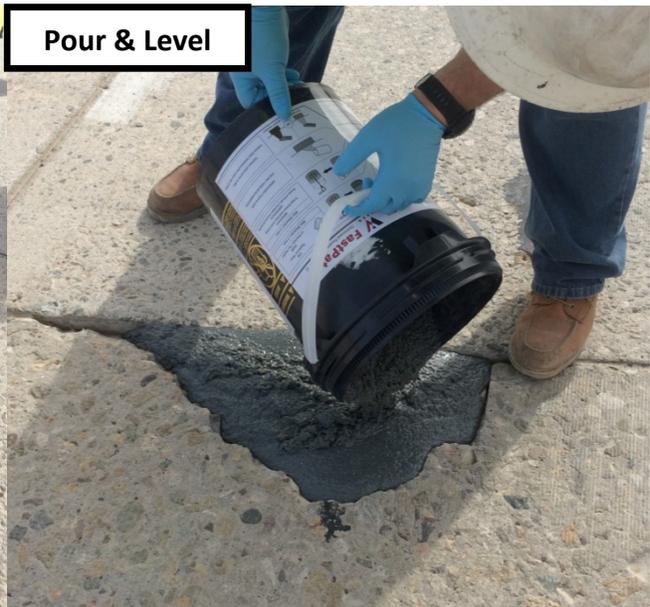
Pour & Level
